# NAVAL SUBMARINE BASE KINGS BAY FLEET MOORINGS UNDERWATER INSPECTION REPORT

MAY 1985

OCEAN ENGINEERING  
AND CONSTRUCTION PROJECT OFFICE  
CHESAPEAKE DIVISION  
NAVAL FACILITIES ENGINEERING  
COMMAND  
WASHINGTON, D.C. 20374

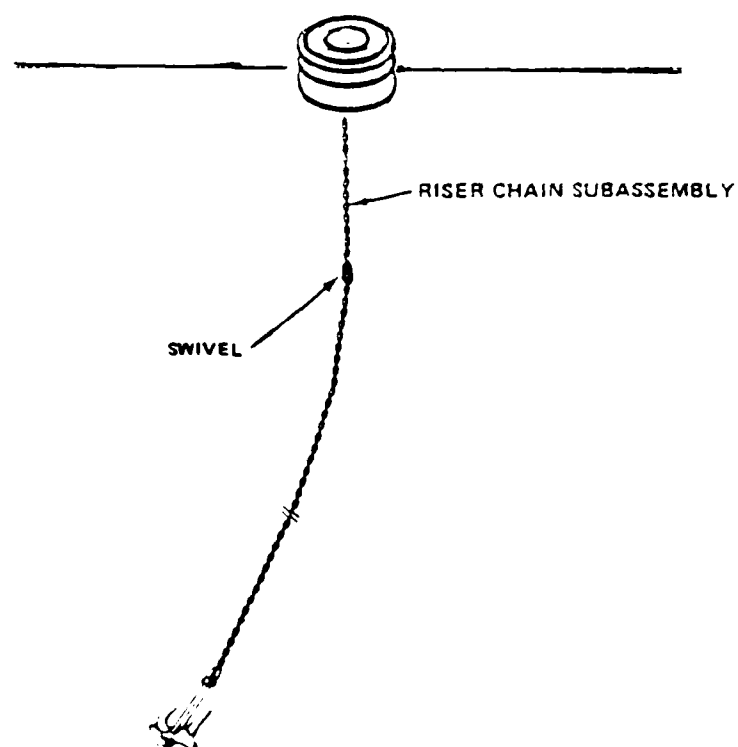
FIGURE 4. "F" Class Mooring Schematic

- o The chain of the two moorings are in good condition with chain measurements greater than 90 percent of original wire diameter.
- o The buoys have severe surface rust and the anodes are completely depleted. These buoys should be overhauled during the next maintenance period.

The three moorings inspected are in satisfactory condition for continued use. However, the two buoys of the "F" Class moorings should be recovered and refurbished as required.
